**In-Service
Mercury Switch Review
July 11, 2003**

**Conducted by the:
Michigan Department of Environmental Quality
Environmental Science and Services Division
Pollution Prevention and Compliance Assistance Section**

In-Service Mercury Switch Review Outline

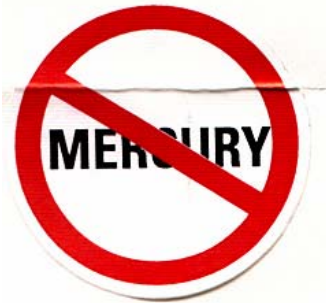
Other possible alternatives exist. For instance, a label similar to what the Oregon NATA Program uses, which is a door post label, shown below:
(Actual size is 1 1/4" round)

This label could, however, be somewhat misleading as other mercury-containing devices such as ABS brakes and HID headlamps may not have been removed from the vehicle.

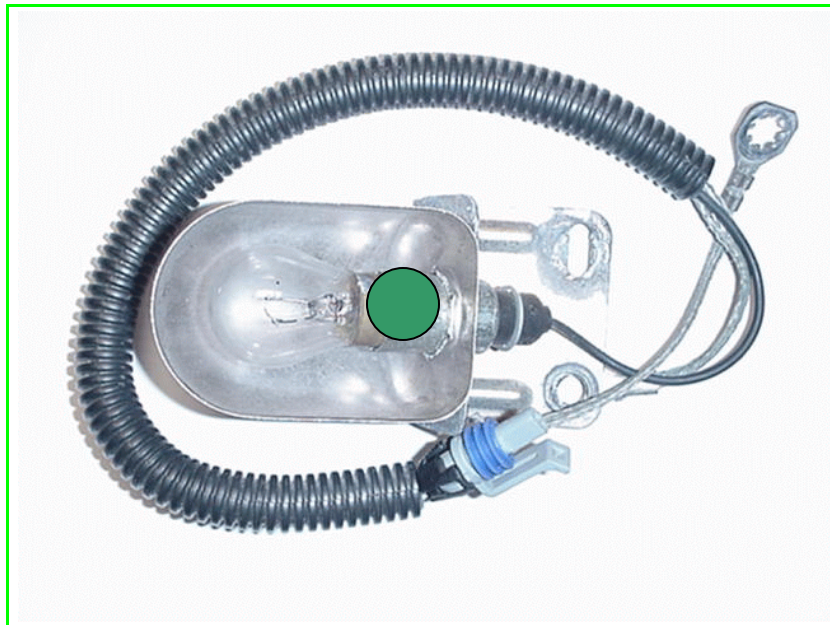
GM HOOD 1970 - 2001

The types of automotive lighting assemblies that are amenable to replacement are limited to a few types that are found in Chrysler, GM, and Ford vehicles. It is estimated that 20-40 percent of automotive lighting assemblies found in Chrysler, GM, and Ford vehicles (1950 – 2001; Chrysler ending in 1997) contain mercury switches that can be replaced without destroying the assembly. Some of the common types that can be replaced are included in the following examples:
